Your Inspection Report

12 Hewitt Crescent
Ajax, ON L1S 7A2

INSPECTION DATE:
Monday, October 19, 2020

RE: Report No. 3296
12 Hewitt Crescent
Ajax, ON
L1S 7A2

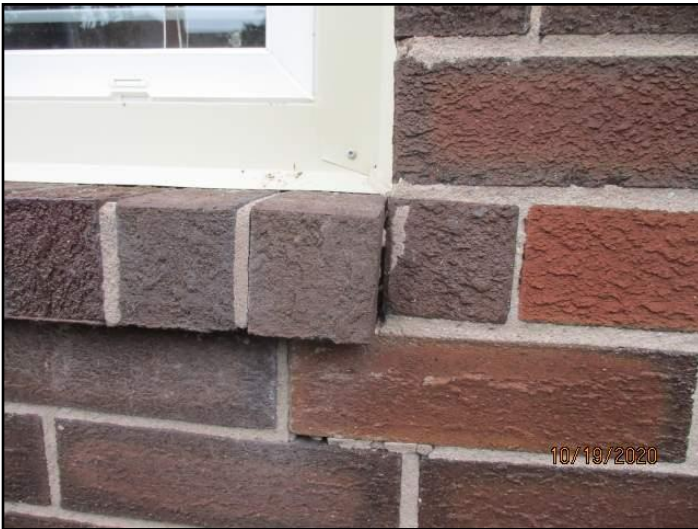
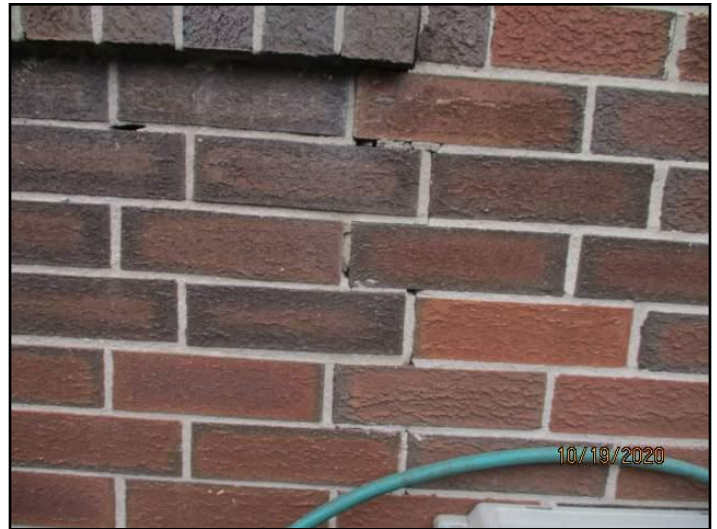
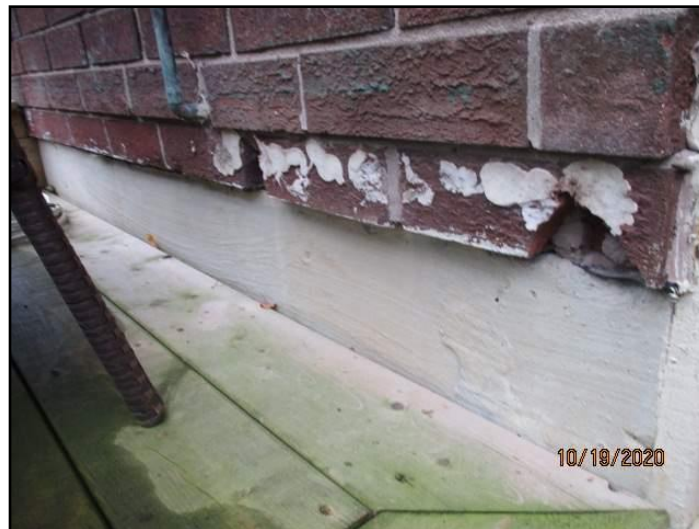
Condition: • Repair the gaps and openings in the brickwork where needed to help prevent further deterioration.

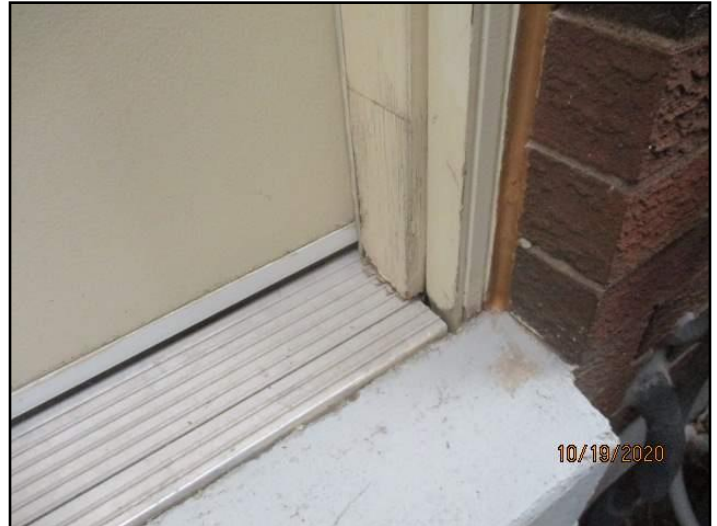
14.

Condition: • Paint, caulk and seal the exterior door trim and fill all gaps in the sill where needed.

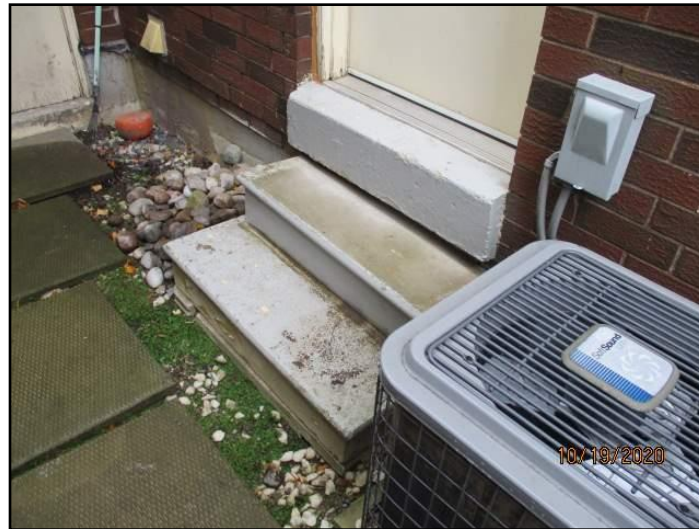
15.

Condition: • Trip hazard

Level the side entrance stairs where needed.

Implication(s): Trip or fall hazard

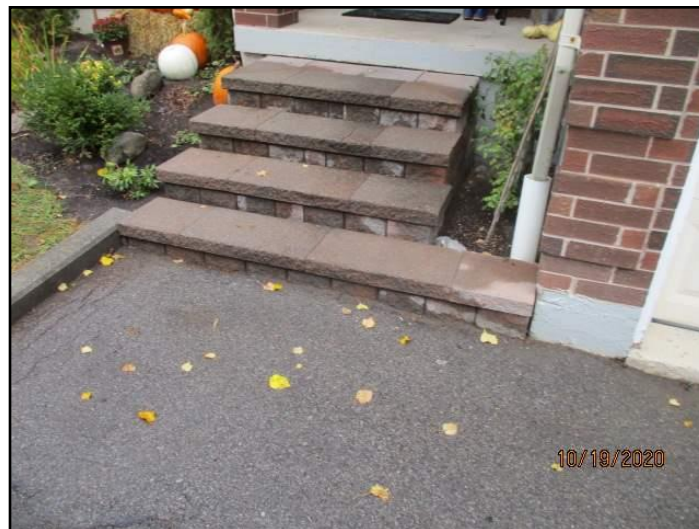
16.

Condition: • [Missing](#)

A handrail is needed for the front steps as there are 4 steps plus the landing.

Implication(s): Fall hazard

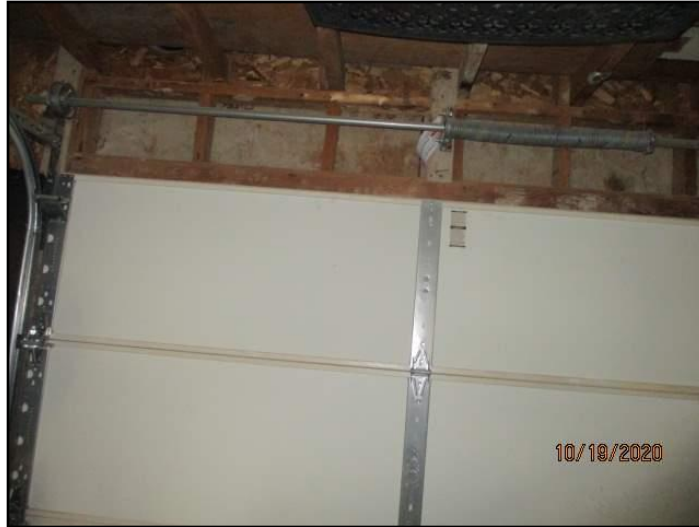
17.

Condition: • Difficult to open or close

The garage door could be adjusted and setup up properly to make operation easier.

Implication(s): Reduced operability

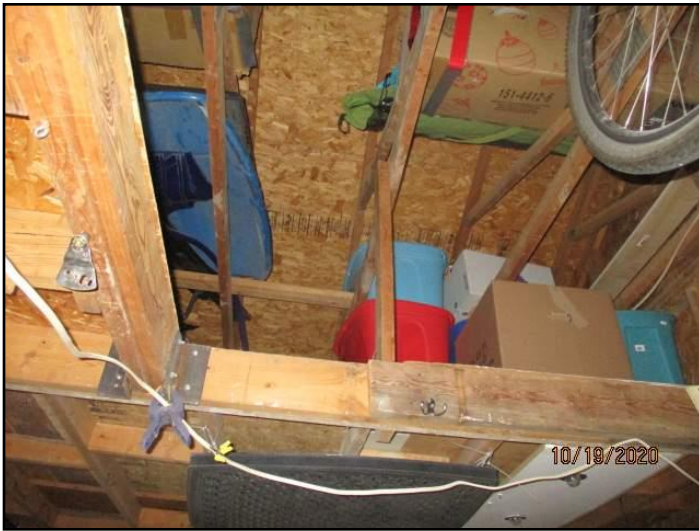
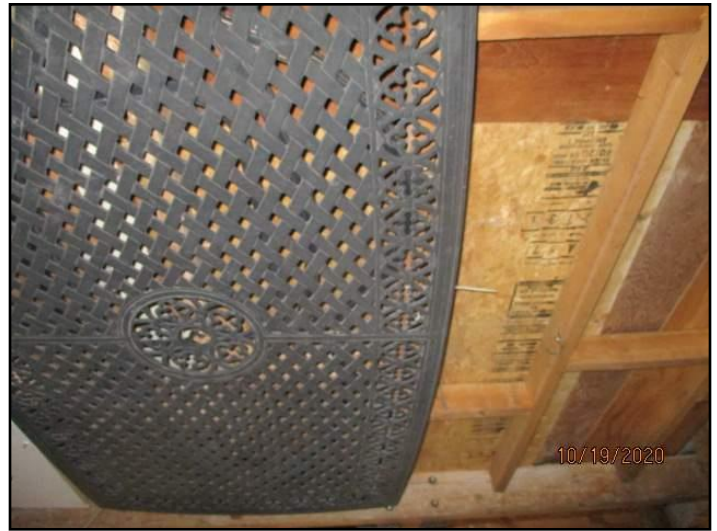
Condition: • Improve the garage shelf support or remove them.

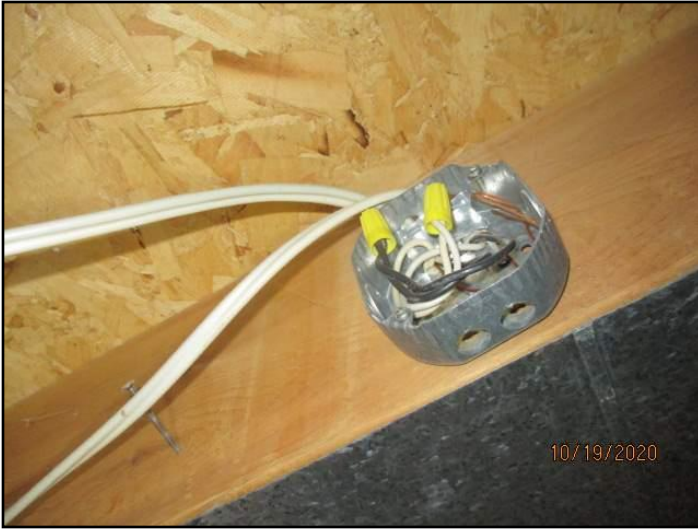
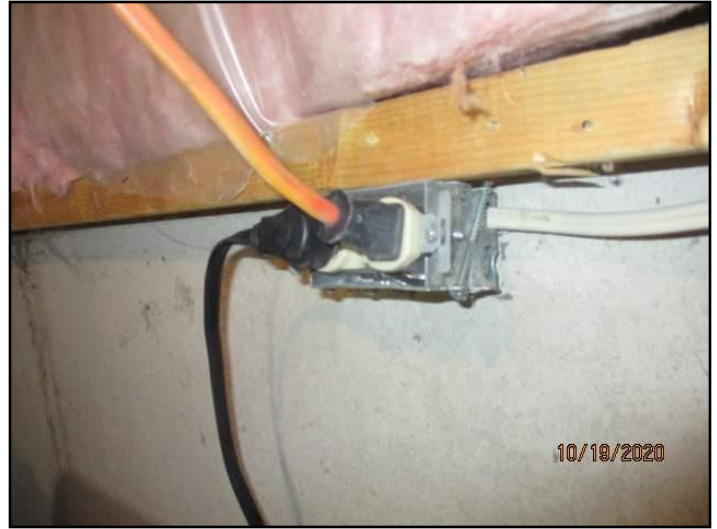
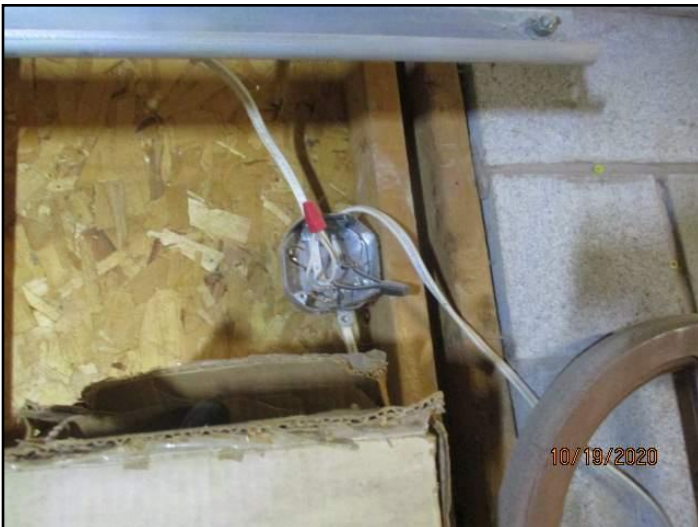
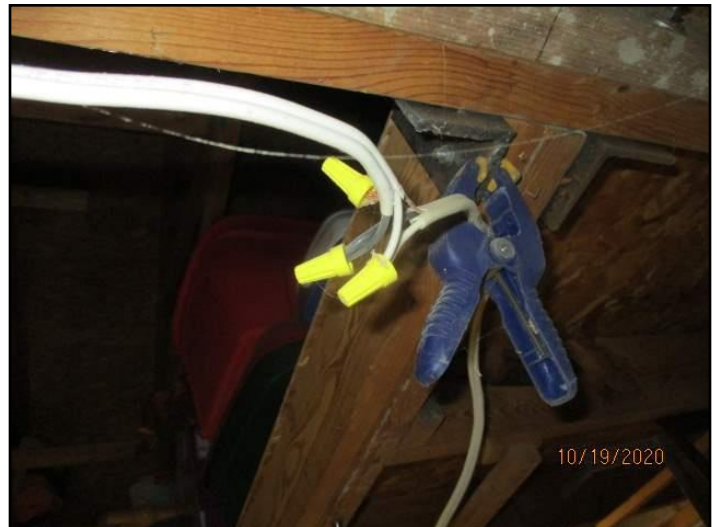
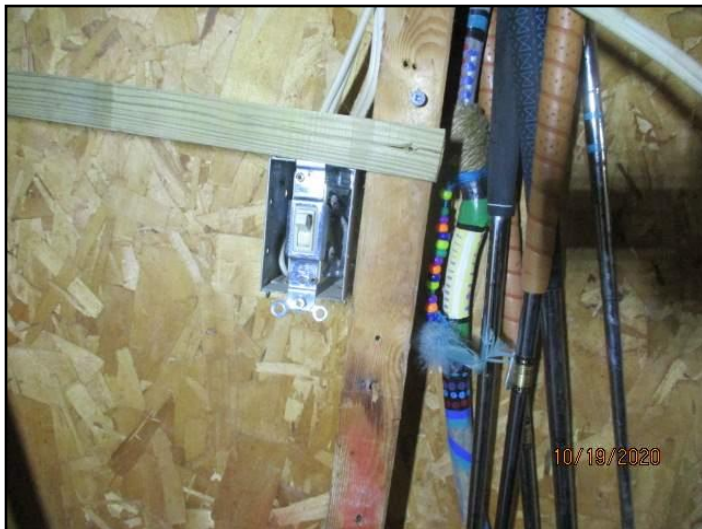
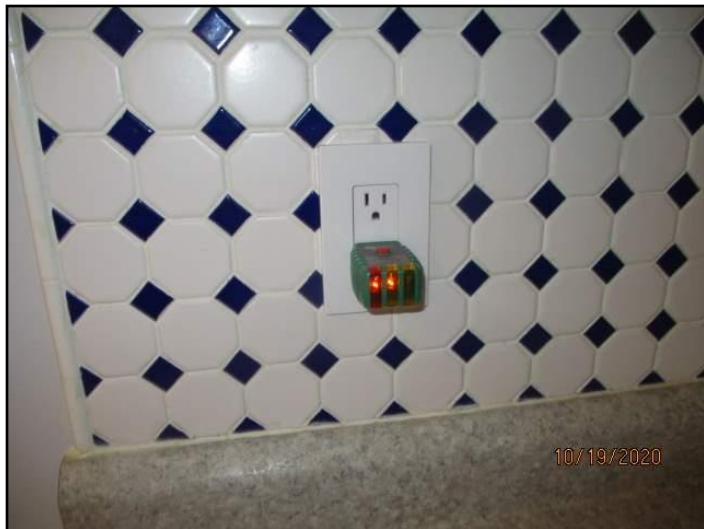
Condition: • There are some electrical box covers missing, the dryer wire needs to be secured to the wall better, there is a wiring connection in the garage that is missing a box, the outlet by the kitchen sink is wired incorrectly and the microwave is run off an extension cord plugged into the counter plug. Have all electrical defects repaired for safety.

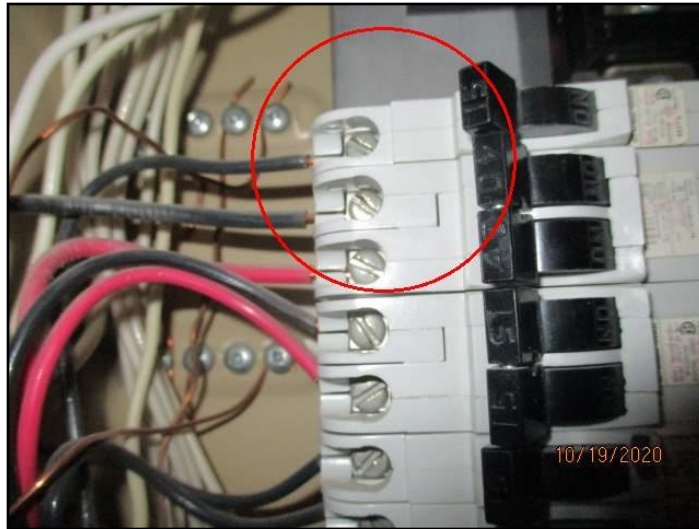
36.

Condition: • [Wrong fuse or breaker size](#)

Replace the 40 amp breaker for the dryer with a 30 amp breaker as the wire thickness determines the size of the breaker and this is incorrect.

Implication(s): Equipment overheating | Damage to equipment | Fire hazard

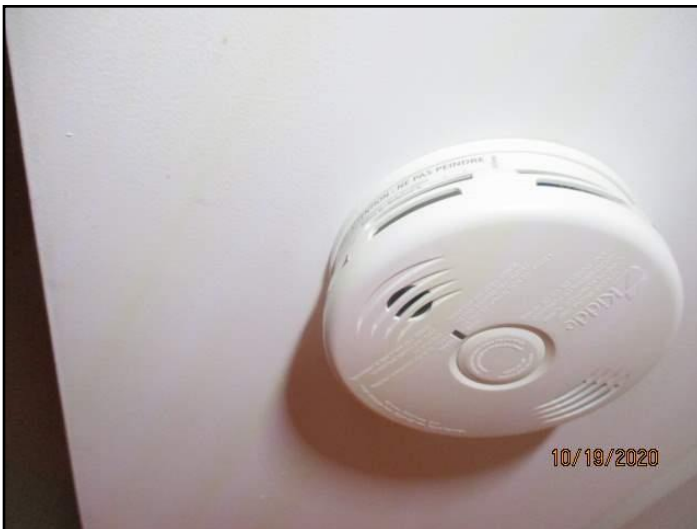
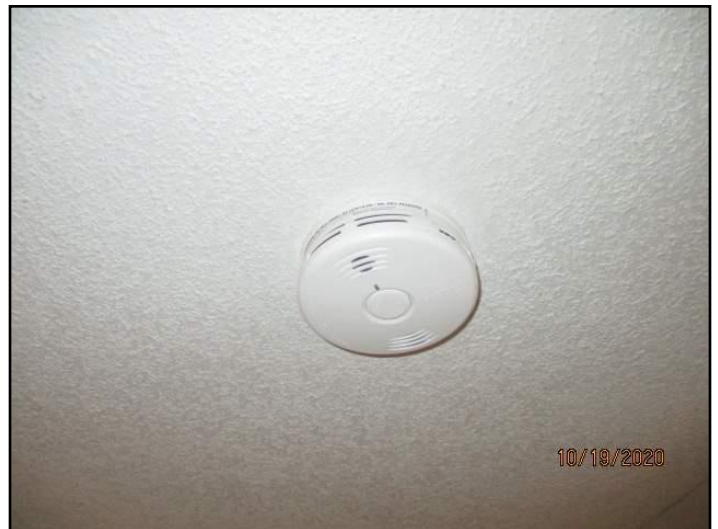
Condition: • I suggest you replace all smoke alarms and CO detectors when you move in.

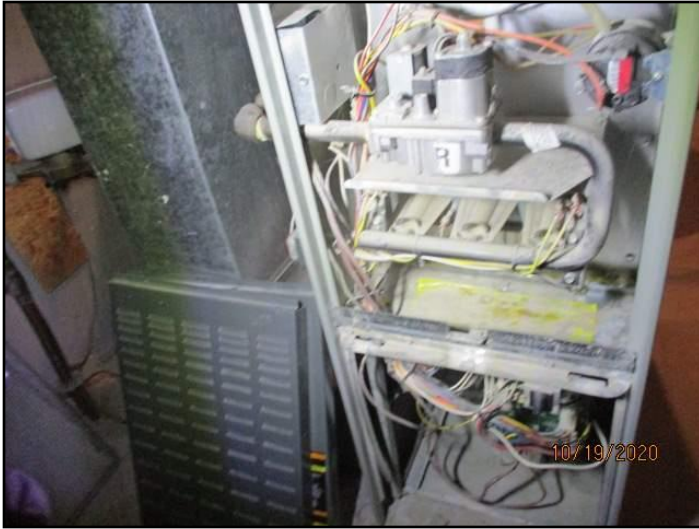
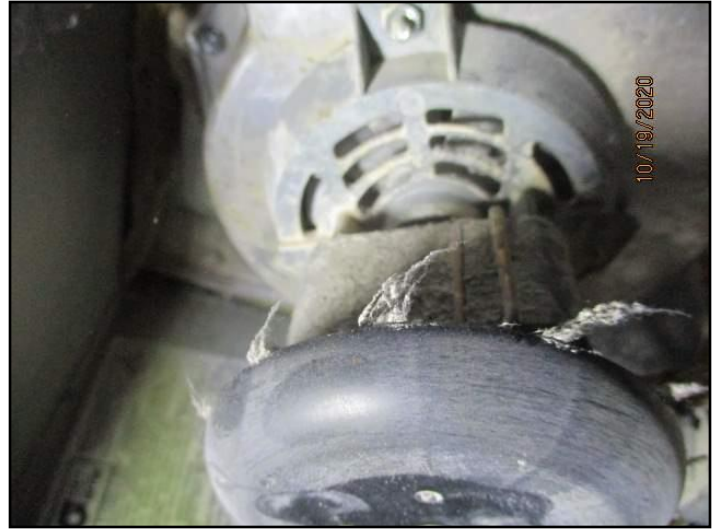
Condition: • Service Furnace

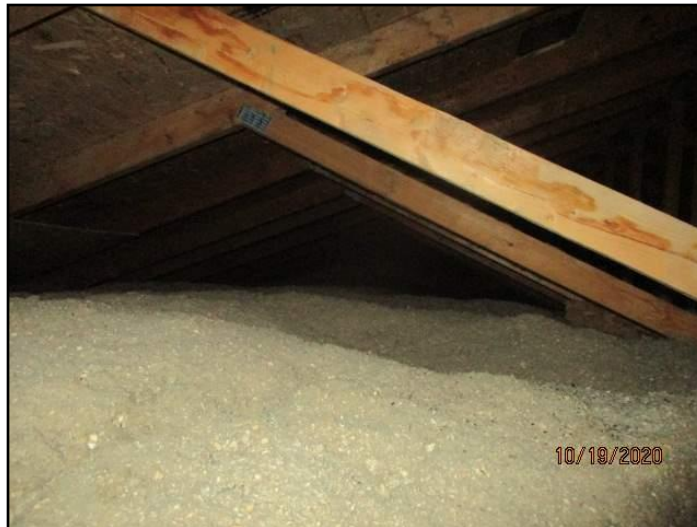
46.

Condition: • [Amount less than current standards](#)

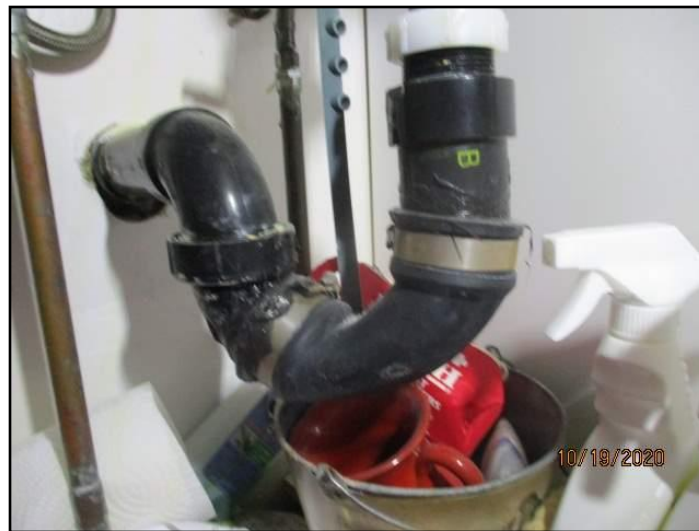
51.

Condition: • Replace the rubber hose and clamps below the 2nd floor bathroom sink with a proper trap to help prevent leaks. The parts to fix this properly are probably about \$25 in materials.

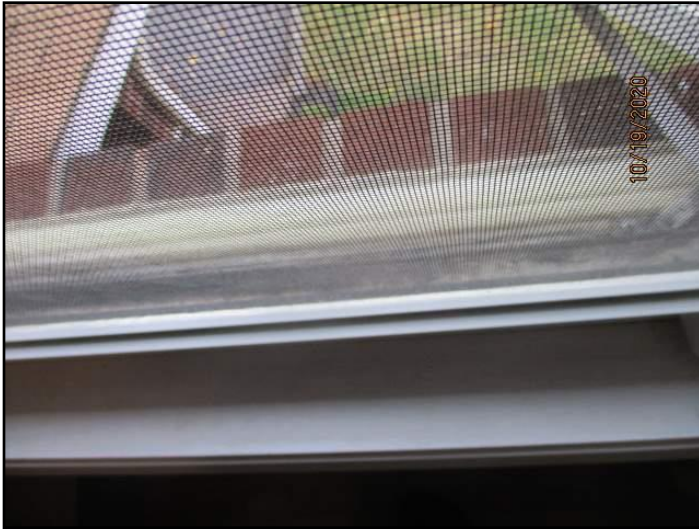
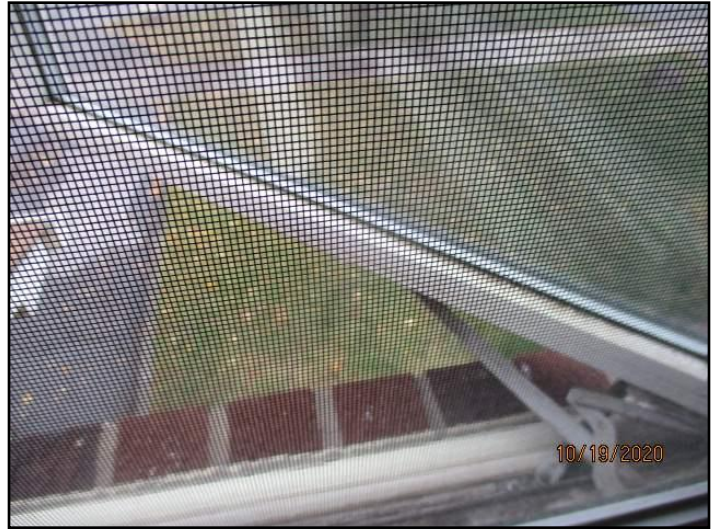
Condition: • Clean the inside of the the window frames and sills where needed.

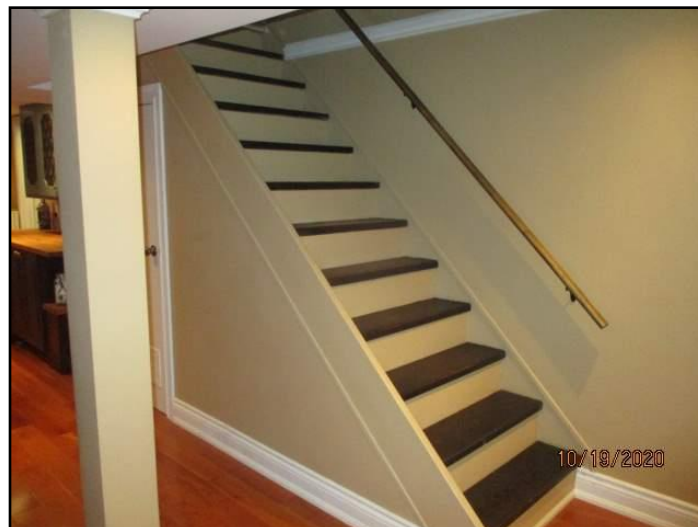
66.

Condition: • [Missing](#)

Implication(s): Fall hazard

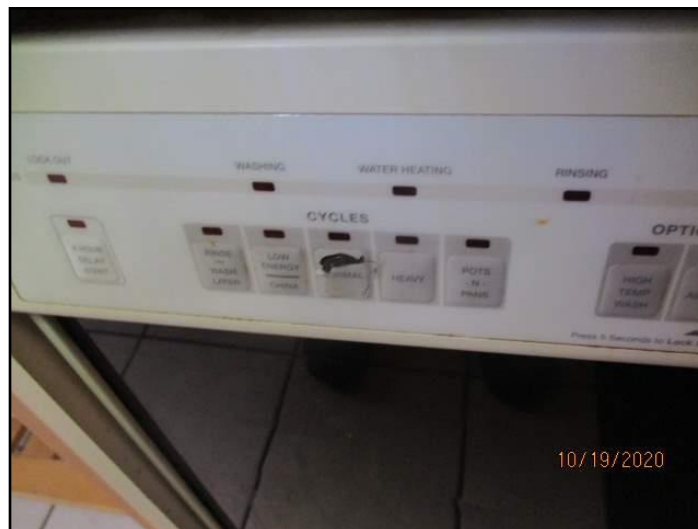
68.

Condition: • Some of the buttons on the dishwasher are worn through.

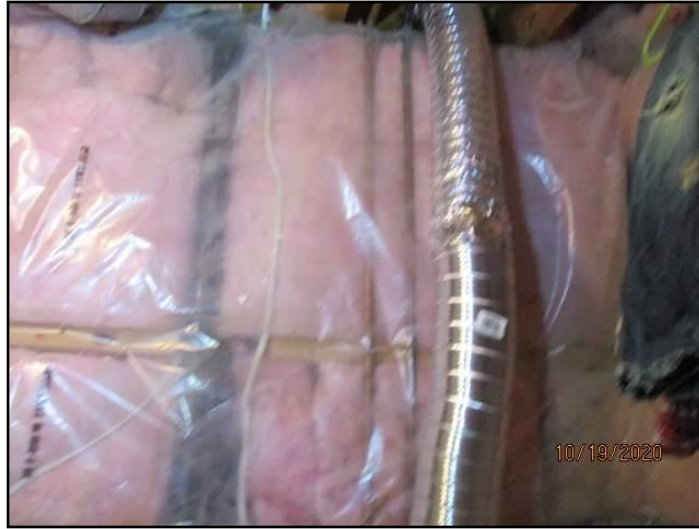
69.

Condition: • Dryer vent material not smooth wall

Replace the dryer vent pipe with a smooth wall pipe and always keep it clean.

Implication(s): Equipment ineffective | Fire hazard
