INSPECTION REPORT

For the Property at:
1574 ALWIN CIRCLE
PICKERING, ON L1V 2W2

Prepared for: GEORGIANA WOODS
Inspection Date: Friday, September 25, 2020
Prepared by: Enio Ferri RHI

RE: Report No. 1605
1574 Alwin Circle
Pickering, ON
L1V 2W2

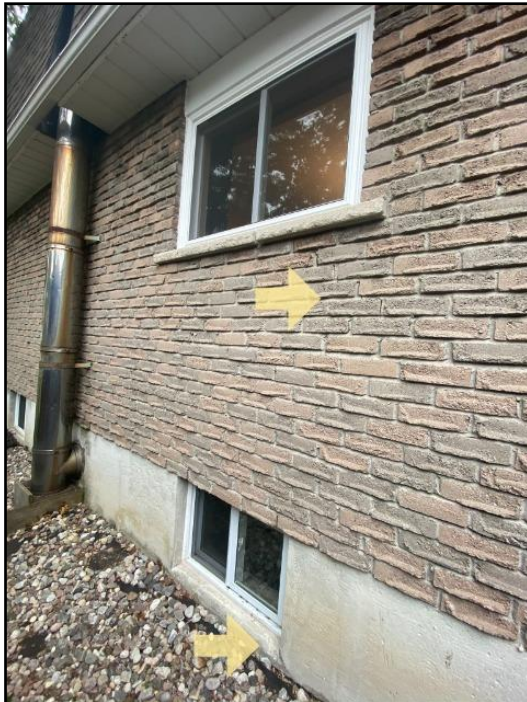
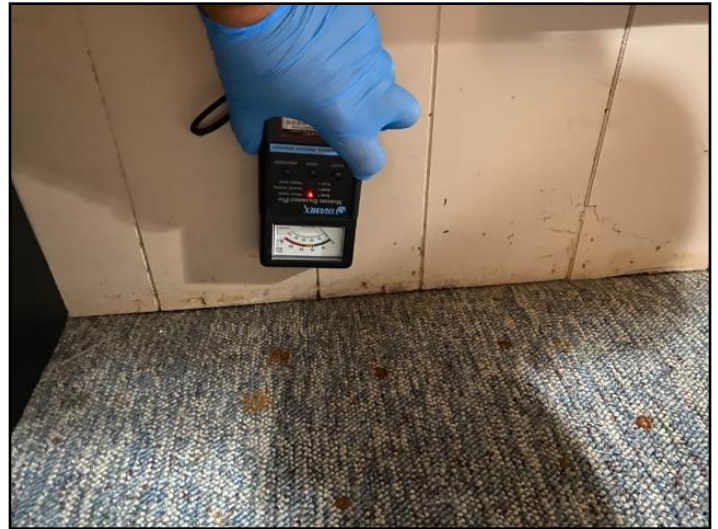
Condition: • [Mechanical damage](#)

Step cracking is noted on the right side of the home, No moisture was detected, repairing of the crack is recommended.

Implication(s): Chance of water entering building | Weakened structure

1. Mechanical damage

2. Mechanical damage

Task: Repair

Time: Less than 1 year

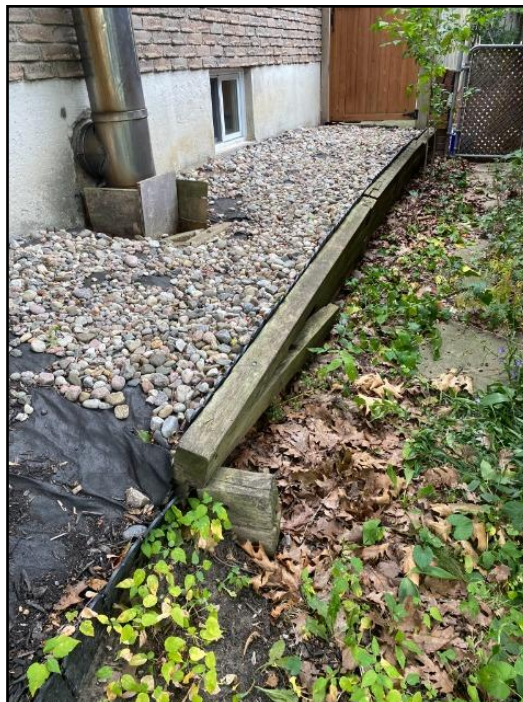
Condition: • [Leaning](#)

Implication(s): Weakened structure | Chance of movement

3. Leaning

Task: Repair

Time: If necessary

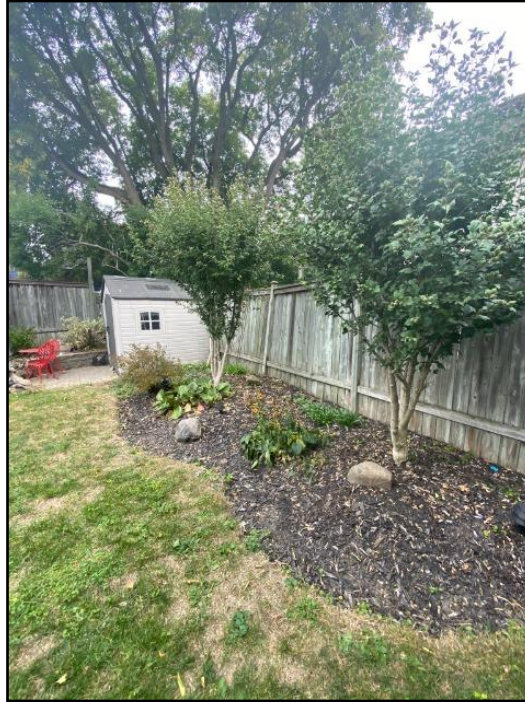
Condition: • Leaning

Implication(s): Chance of movement | Damage or physical injury due to falling materials

4. *Leaning*

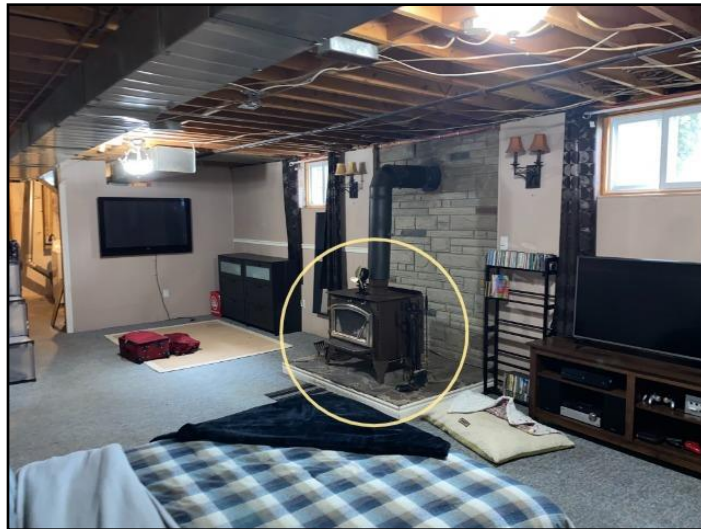
Condition: • Inspect chimney, and sweep, if needed before using

Implication(s): Fire hazard

5. *Inspect chimney, and sweep, if needed befor...*

Task: Further evaluation

Time: Immediate

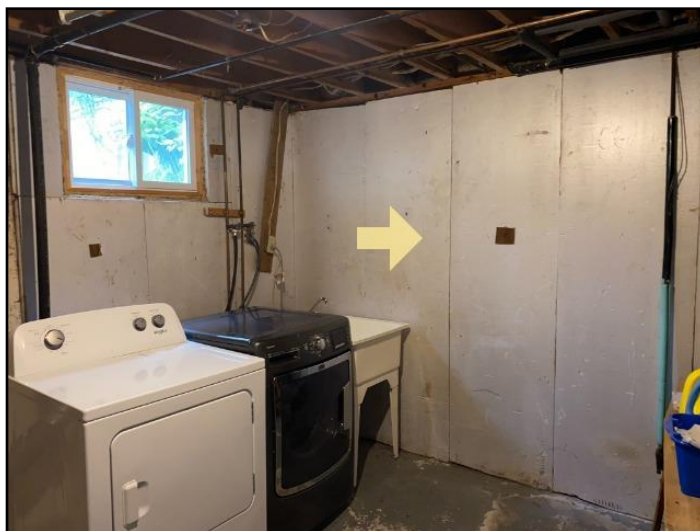
Condition: • [Exposed combustible insulation](#)

Implication(s): Fire hazard

6. Exposed combustible insulation

Task: Protect

Time: Immediate
