Your Inspection Report

12 Hewitt Crescent
Ajax, ON L1S 7A2

INSPECTION DATE:
Monday, October 19, 2020

RE: Report No. 3296
12 Hewitt Crescent
Ajax, ON
L1S 7A2

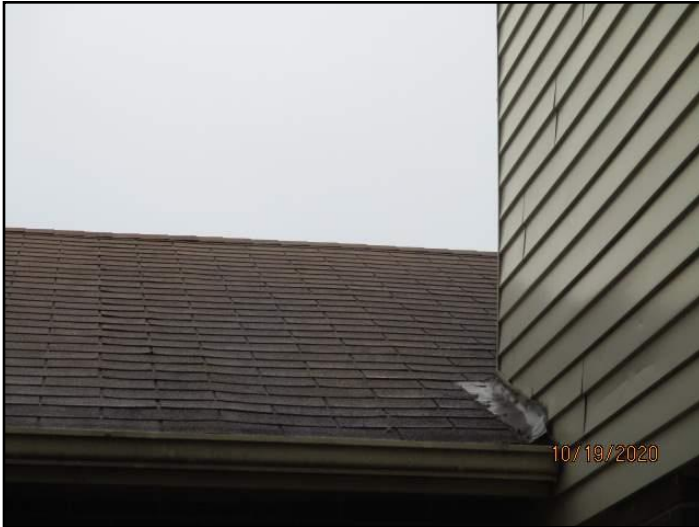
1.

Sloped roofing material:

- [Asphalt shingles](#)

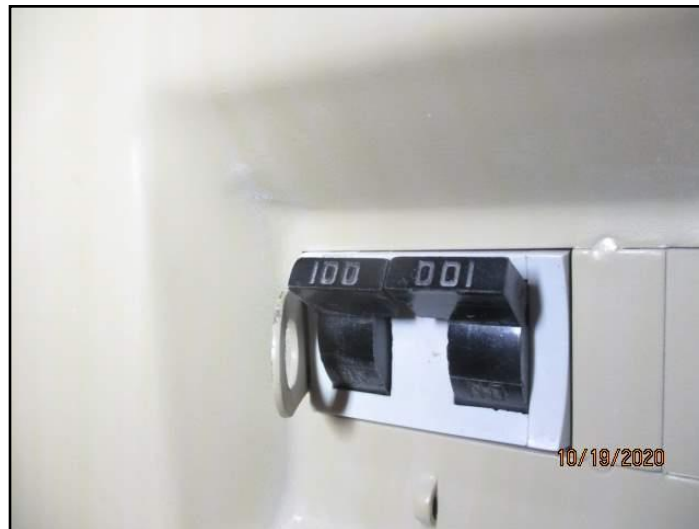
24.

Main disconnect/service box rating:

- [100 Amps](#)

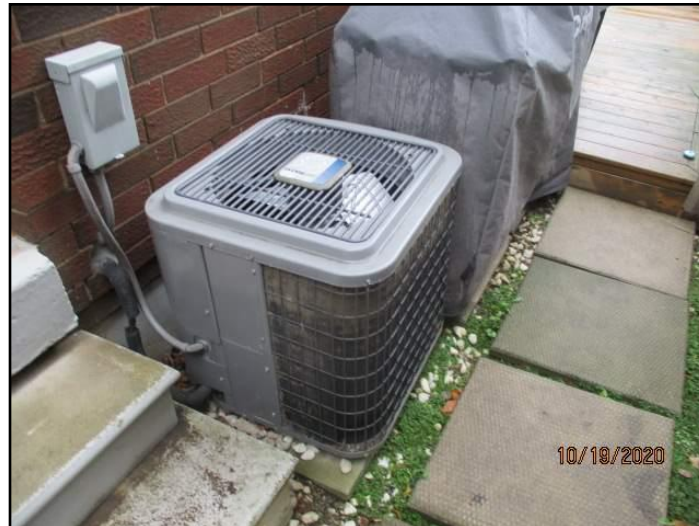
44.

Air conditioning type:

- [Air cooled](#)

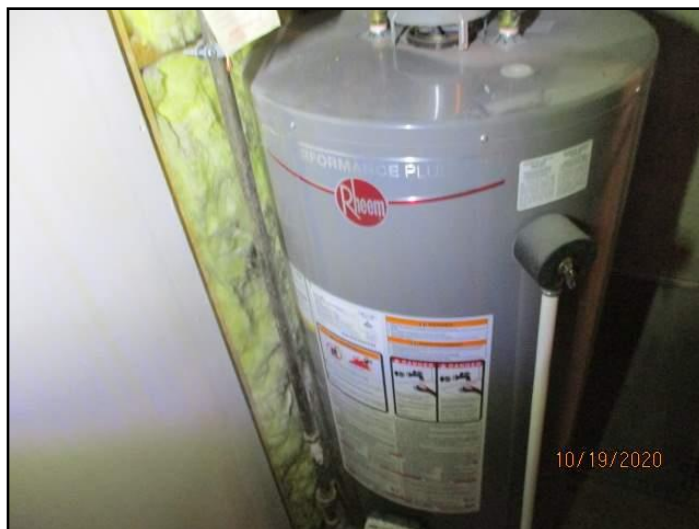
48.

Water heater type:

• [Conventional](#)
